Determination of the Life Remaining in the Model HU-16E Airplane Wing

REPORT NO. NADC-ST-7007

DETERMINATION OF THE LIFE REMAINING IN THE
MODEL HU-16E AIRPLANE WING

FINAL REPORT

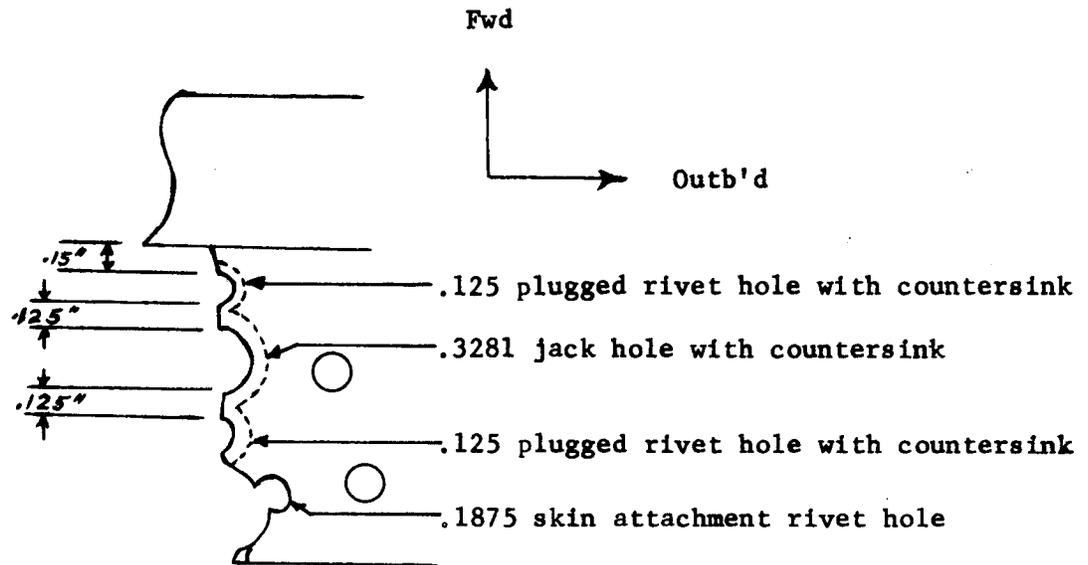
Figure 5

Examination of the fracture surface of the wing catastrophic failure showed the presence of two 1/8 inch diameter rivet holes, one forward and one aft of each jack hole. These can be seen in figure 5 and photos 13, 14, 15, 16, 17, and 23. Investigation revealed that these two rivet holes are called out in the GAEC drawing 85011 for the short wing model airplane as being for AD-4 rivets to hold the jack fitting retaining clip. During the conversion from the short wing to the long wing version of the airplane, these rivet holes were plugged, steel straps installed over the holes and new retaining clip fastener holes were drilled at a spanwise distance from the jack holes (outboard of the outboard jack hole and inboard of the inboard jack hole). As shown in figure 5, there is only 1/8 inch of material between the jack hole and each plugged rivet hole. It is also evident that the jack hole and each plugged rivet hole is countersunk and that these countersinks extended into each other. Also, as shown in the photos listed above, the forward plugged hole is very close to the radius between the horizontal and vertical legs of the spar cap. As can be seen in photo 24, the major portion of the fatigue marks emanate from the plugged rivet holes. It is clearly evident that there was crack initiation at the forward edge of the forward plugged rivet hole and at the aft edge of the aft plugged rivet hole. There was also some crack initiation at the jack pad hole. It is impossible to scientifically determine where the first crack initiated, whether at the jack pad hole or the plugged rivet hole. However, it is believed that the crack originates at the plugged rivet hole. It then progresses a certain amount at which time a crack initiates and grows in the area between the jack and plugged holes. This latter crack progresses to the point where the material remaining between the holes yields. During this time, the cracks which originated at the plugged holes have grown through the area which eventually became washed out. When the material between the holes yielded, the crack from the plugged hole jumped and then continued growing until final failure occurred. This theoretical crack propagation history is sketched in figure 9.

RIGHT-HAND WING, MAIN BEAM LOWER SPAR CAP FAILURE

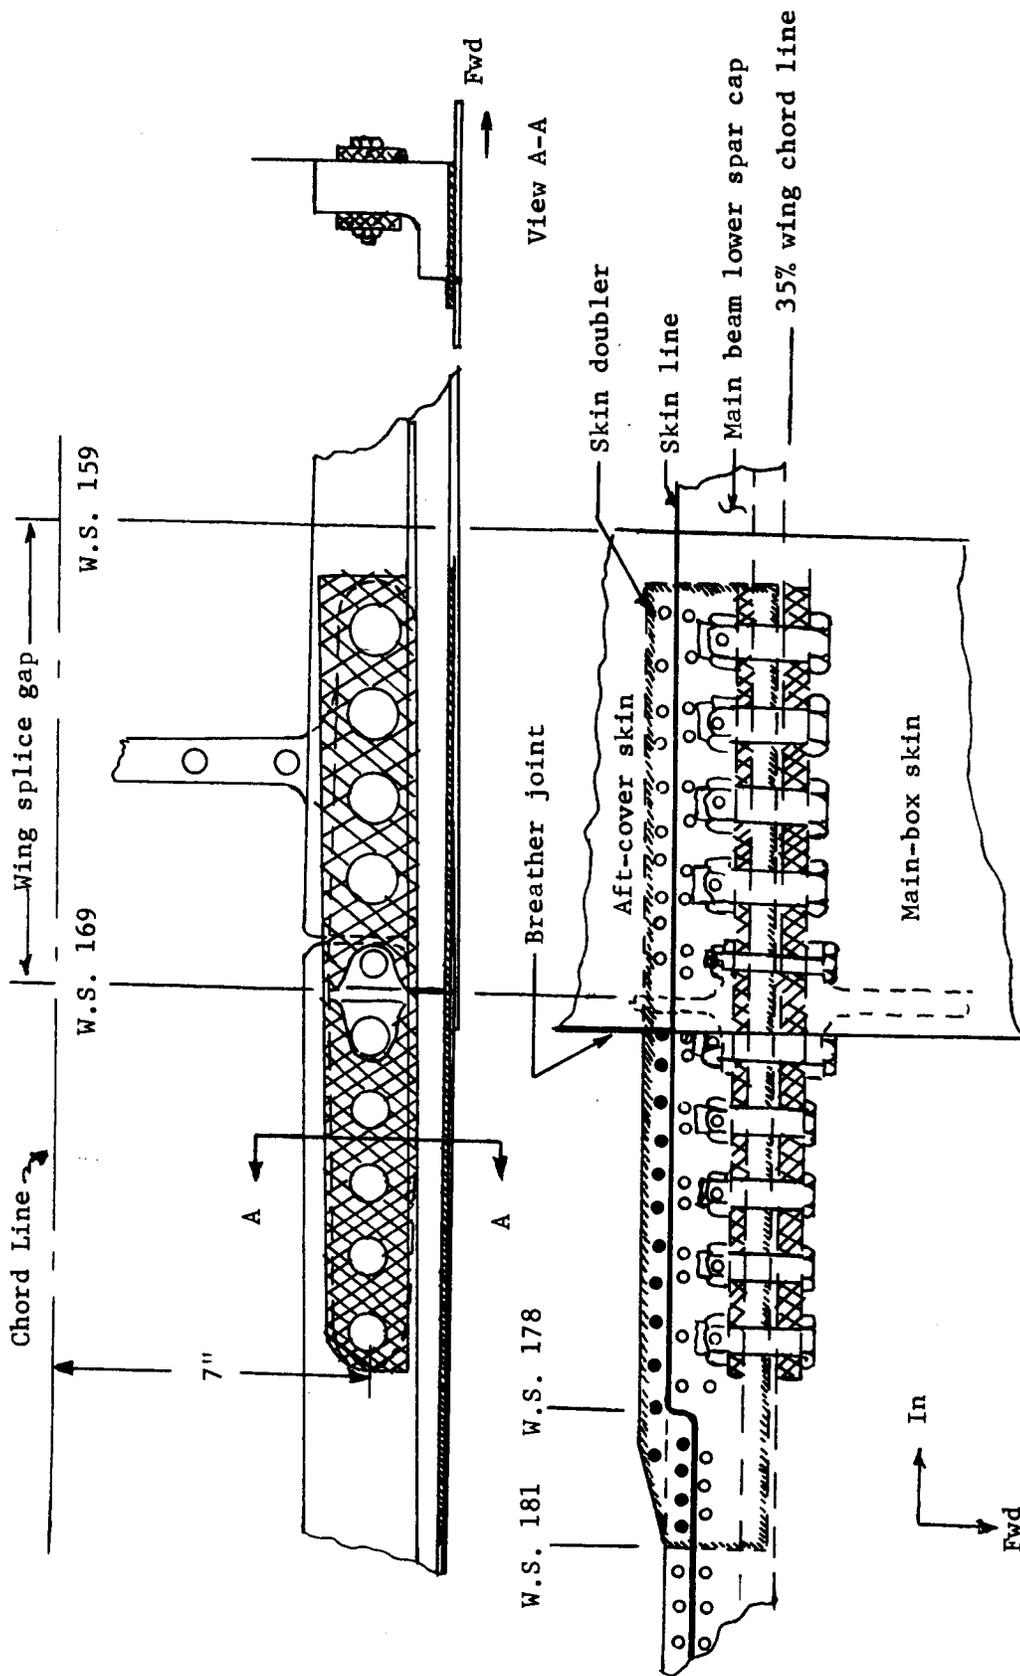
BREATHER JOINT RIVET FAILURES
Figure 8

were endured between the occurrences of the two failures, the rivet failures were outboard of the wing failure, and the rivet failures can be accounted for by a design deficiency. This deficiency is shown in figure 8 and takes the form of a skin doubler splicing across the wing station 169 skin-breather joint. When high loads are encountered, the breather joint tries to breathe, the doubler tries to prevent the movement and, therefore, the rivets outboard of the breather joint fail. These rivet failures are not critical provided the airplane is not loaded beyond 105% of the design limit load. These rivets can be used as a load indicator in that if they are found to be failed on a service airplane it would indicate that the airplane had exceeded 105% of limit load (2.91g).

● Failed rivets

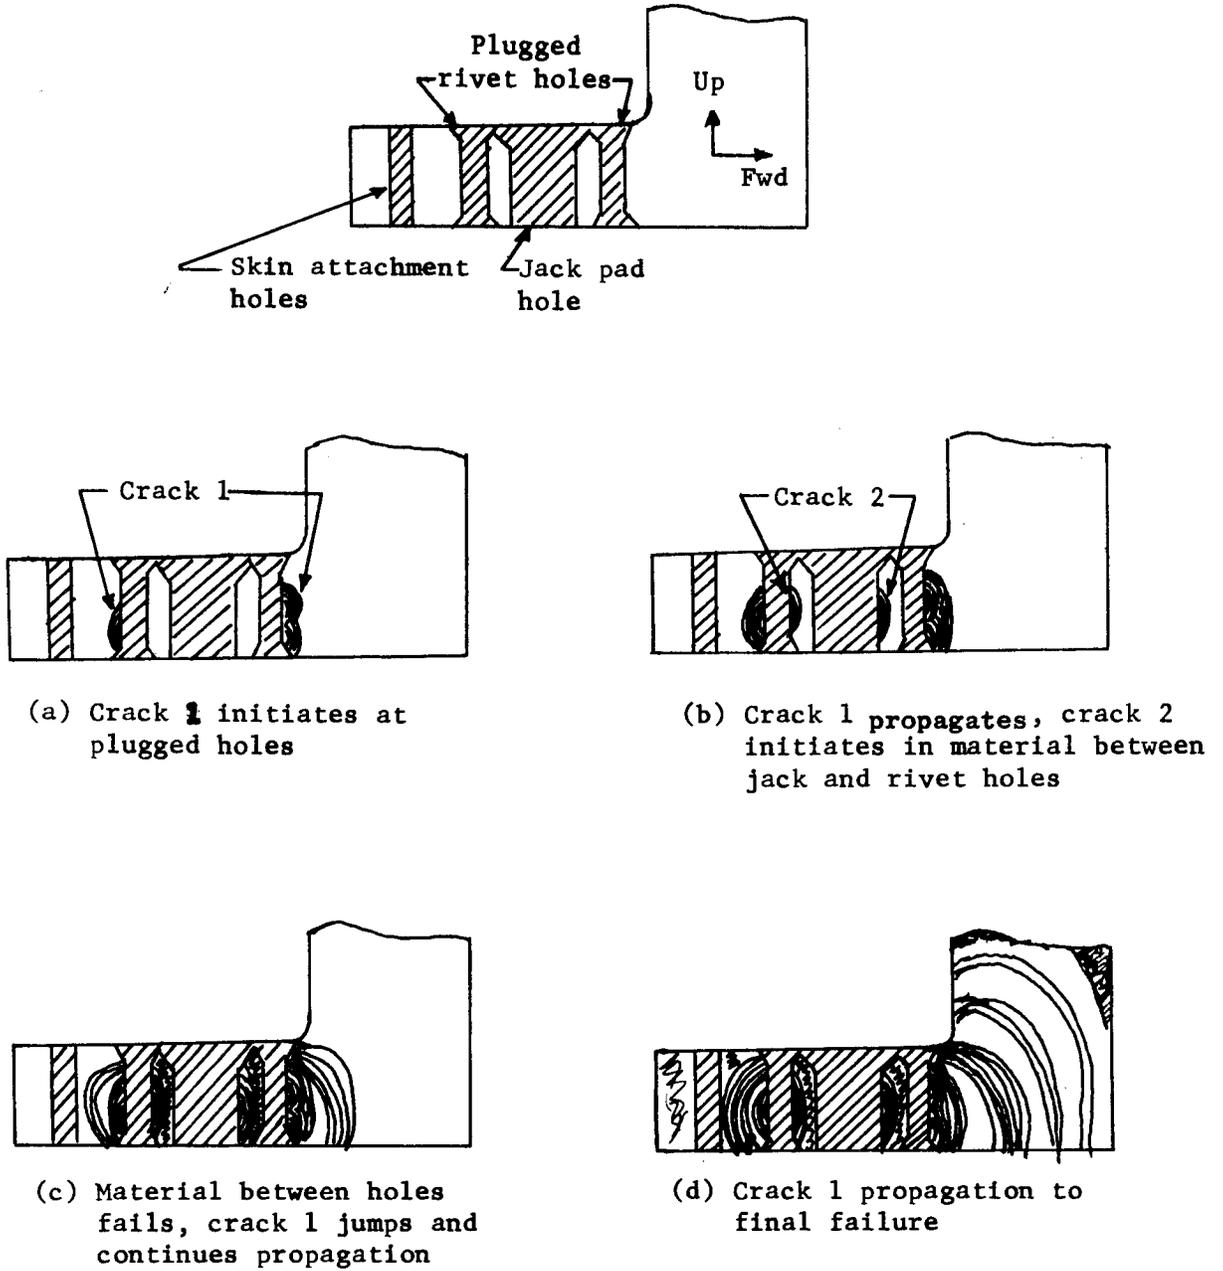
THEORETICAL CRACK PROPAGATION
Figure 9

Various NDI (Nondestructive Inspection) techniques were tried on the test vehicle. As indicated in the Results section of this report no definite cracks were found prior to catastrophic failure. If the theory indicated in figure 9 is correct, an eddy current inspection of the jack pad holes might prove to be an acceptable inspection technique. However, depending on the crack propagation rate in each individual aircraft, crack indications in the jack pad hole might not occur until just prior to catastrophic failure. A more acceptable method of inspection would be to eddy current inspect the plugged rivet holes. This, of course, would necessitate some structural disassembly.

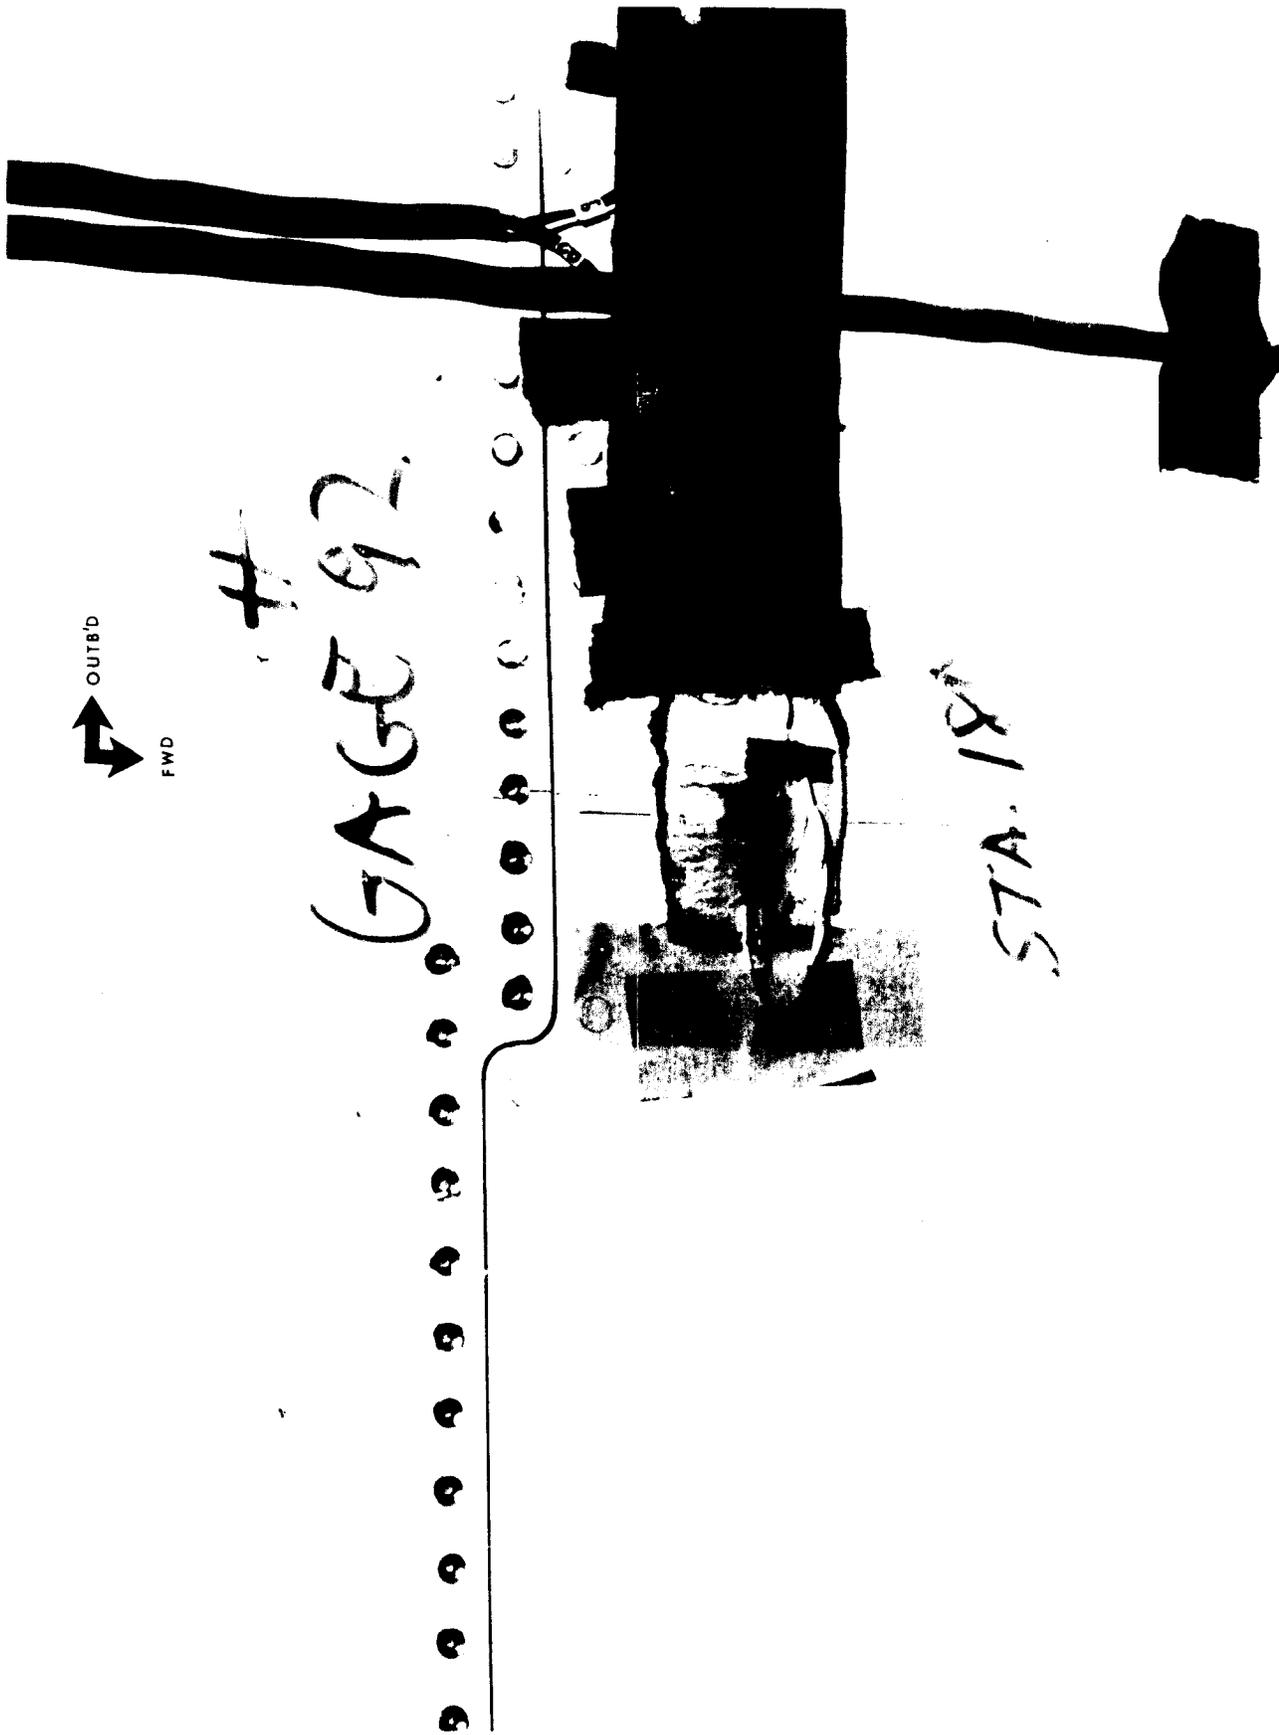
PHOTO 6. CLOSE-UP VIEW OF FAILED RIVETS, RIGHT-HAND WING

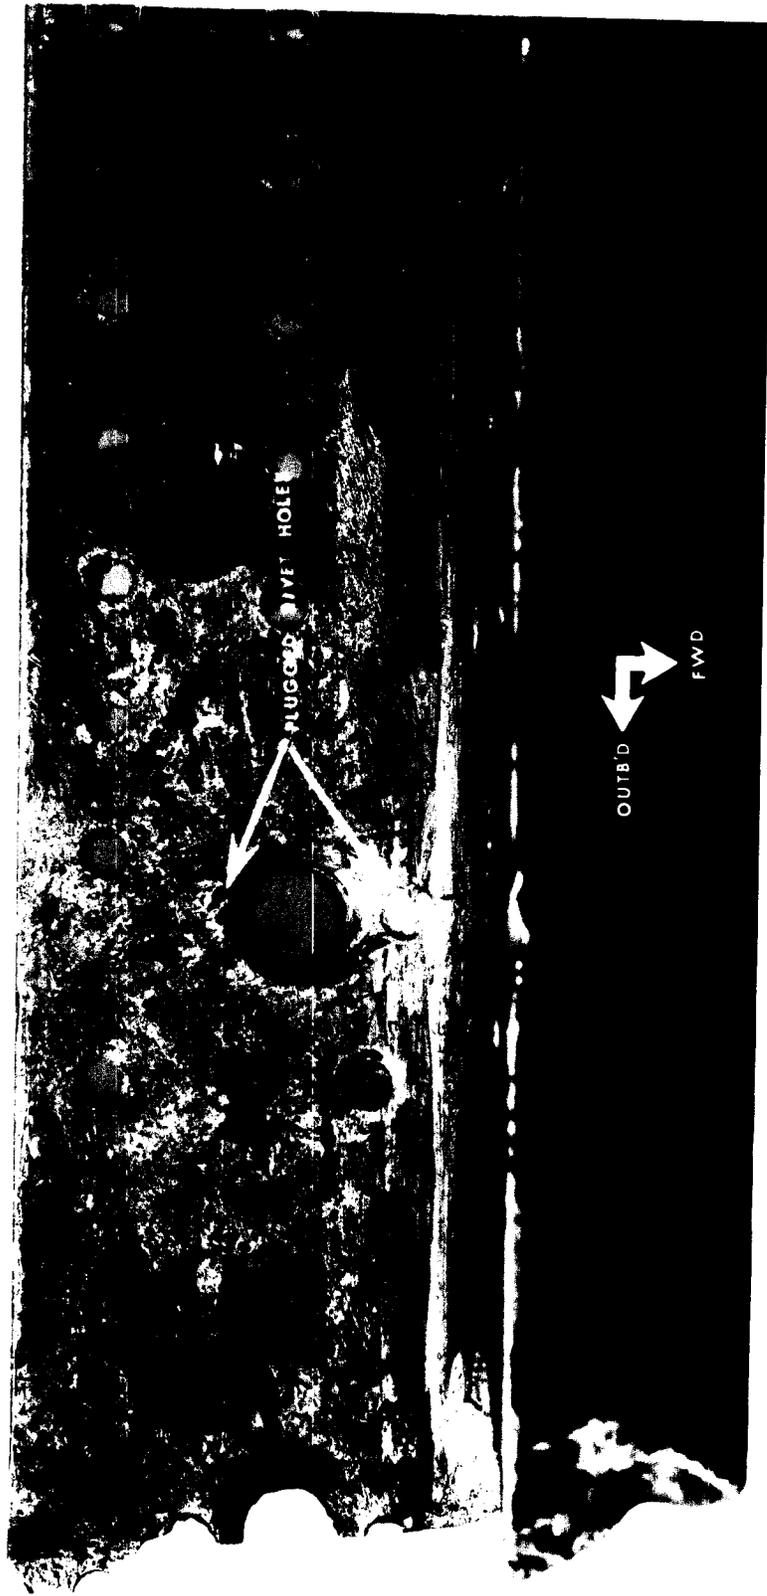
PHOTO NO: CAN-390378(L)-11-68

PHOTO 14. MAIN BEAM LOWER SPAR CAP, VIEW LOOKING DOWN

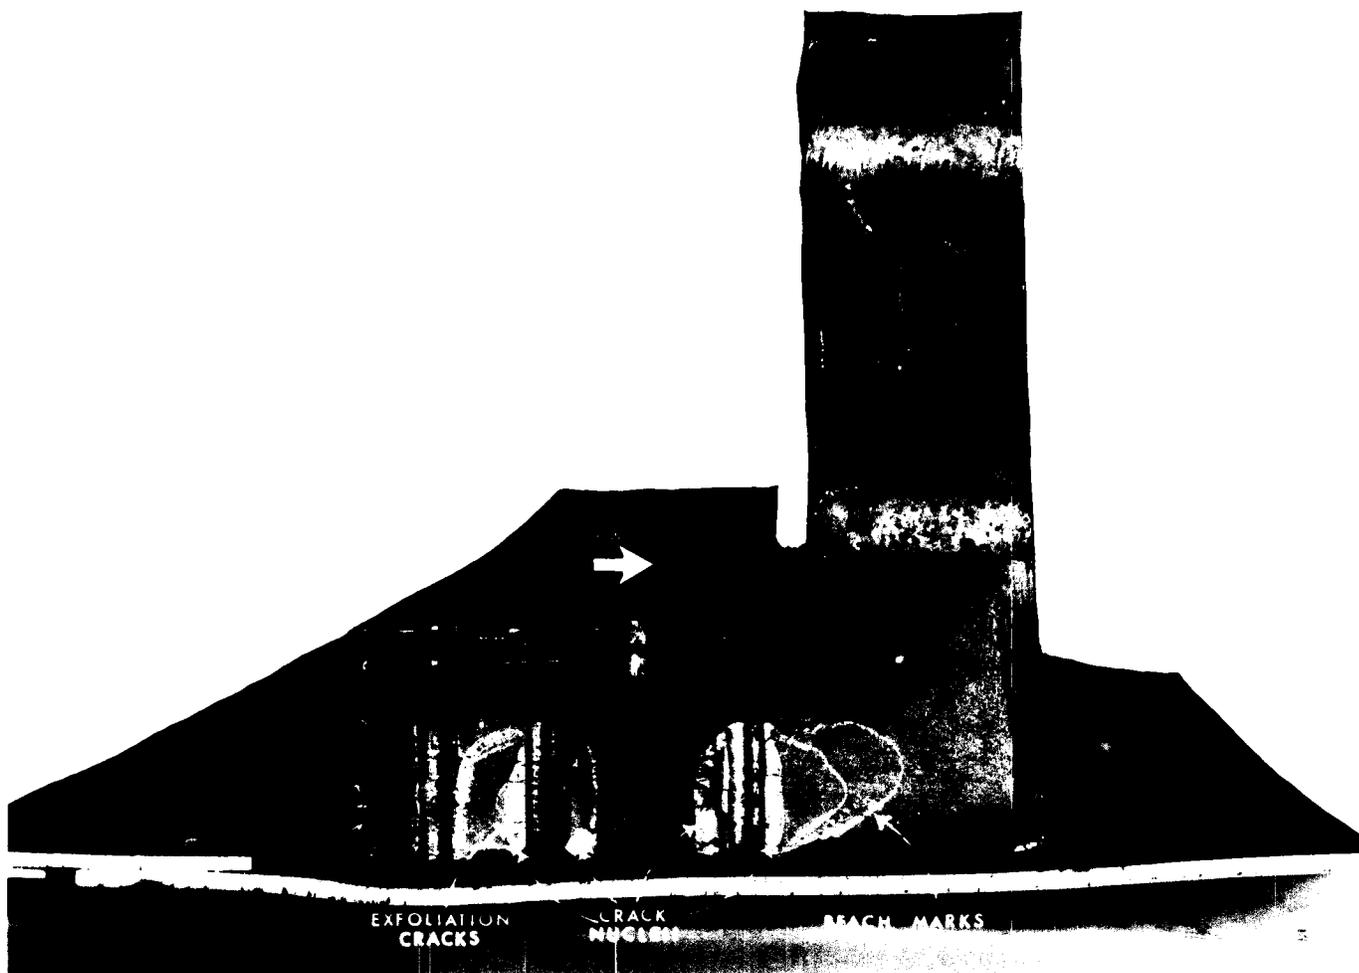
PHOTO NO: CAN-390346(L)-11-68

PHOTO 16. RIGHT-HAND WING FAILURE SURFACE, LOOKING INBOARD

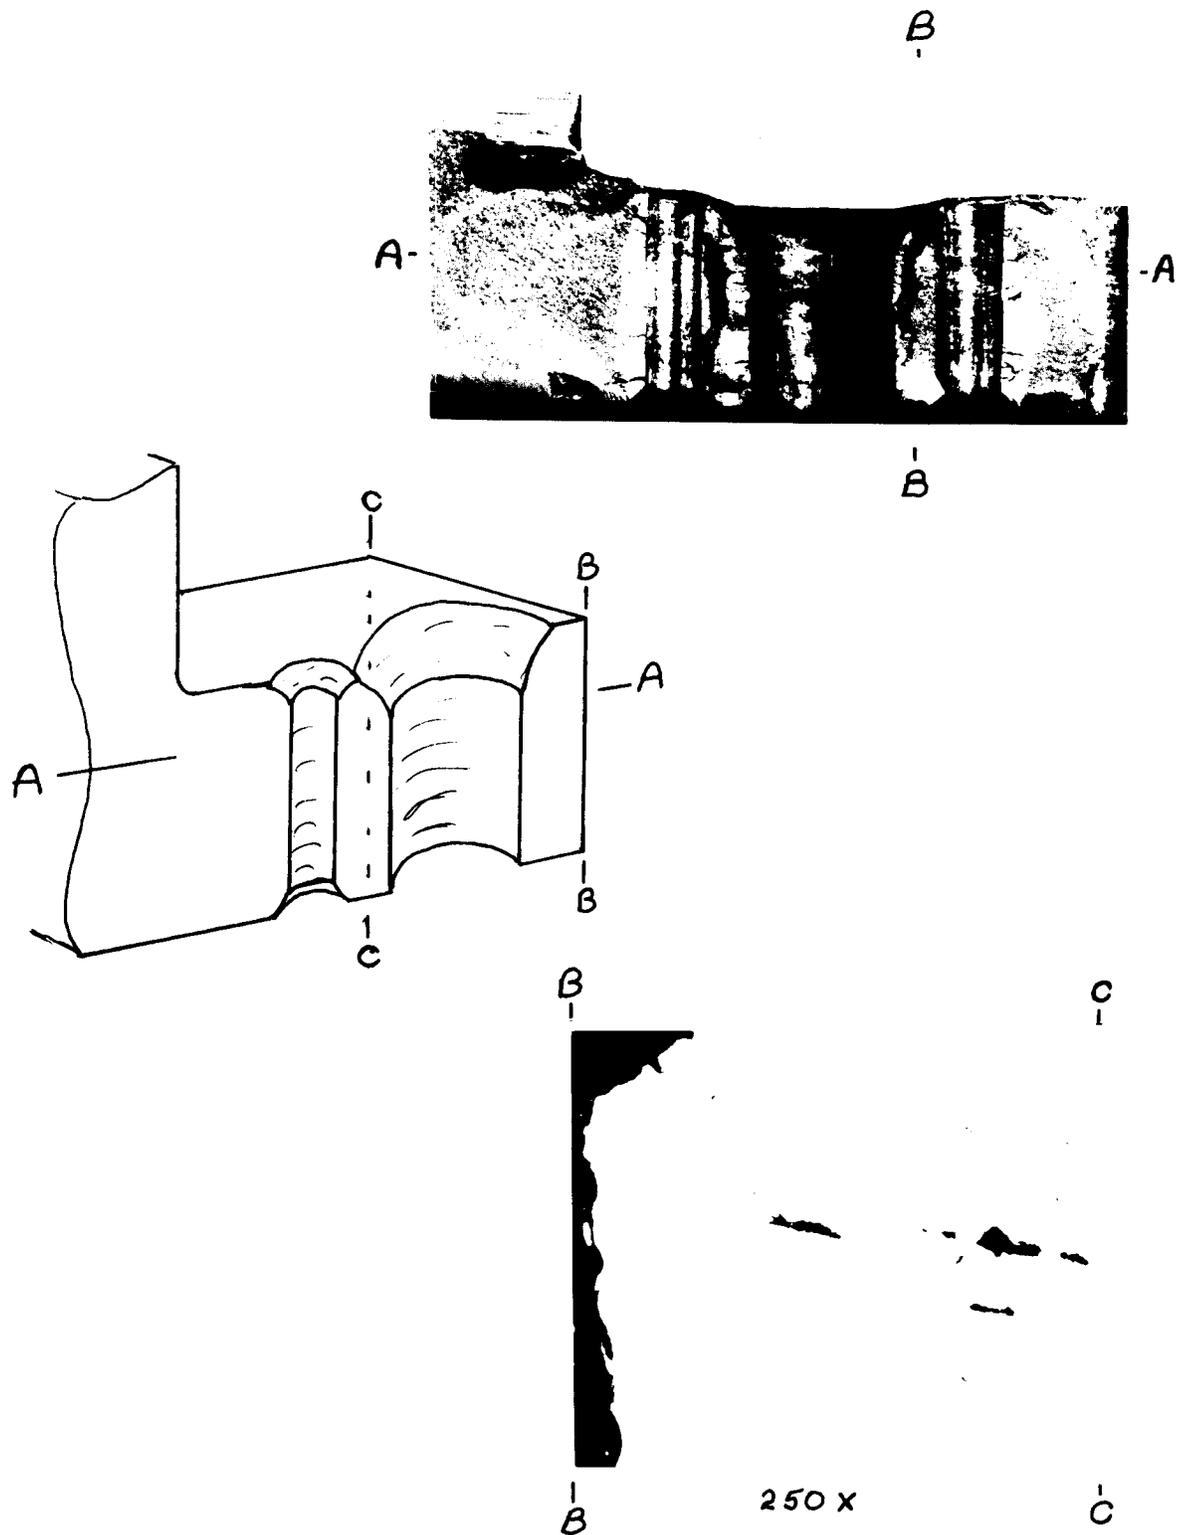
PHOTO 18. COMPOSITE OF SPAR CAP SHOWING FRACTURE SURFACE AND METALLOGRAPHIC SECTION

THE PHOTOMICROGRAPH REVEALS THE PRESENCE OF SECONDARY FATIGUE CRACKS THAT HAVE INITIATED AT SITES OF INTERGRANULAR CORROSION

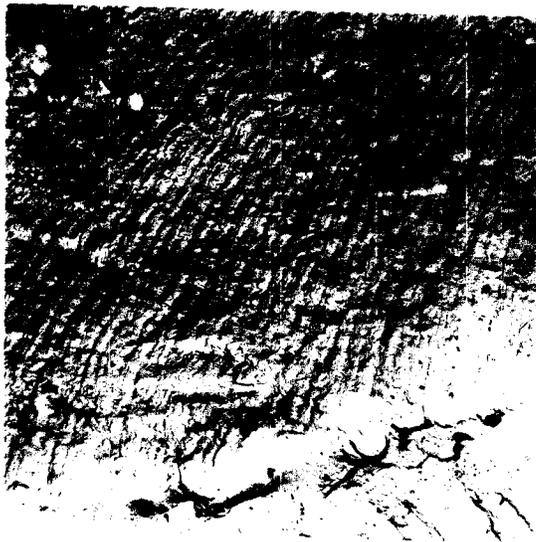
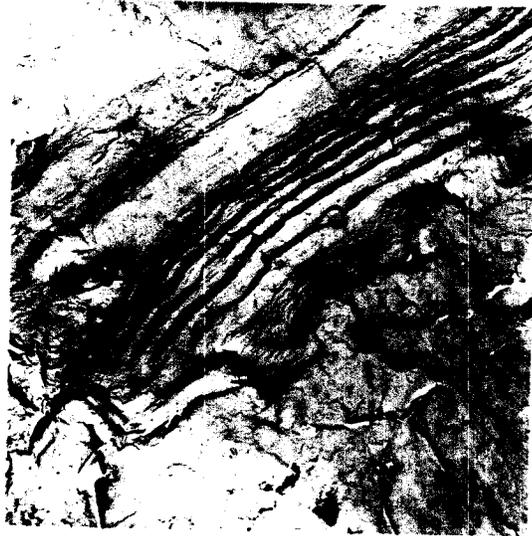
PHOTO 20. FRACTOGRAPHIC OF FRACTURE SURFACE

Fractographic examination of the steel strap failure surface showed a dimpled structure (part C of photo 20) indicative of a ductile fracture caused by a simple overload.

Figs. (a) and (b) are fractographs showing the clearly defined fatigue striations found on the aluminum spar cap; (c) is a dimpled area representative of the ductile rupture mode of the steel straps.

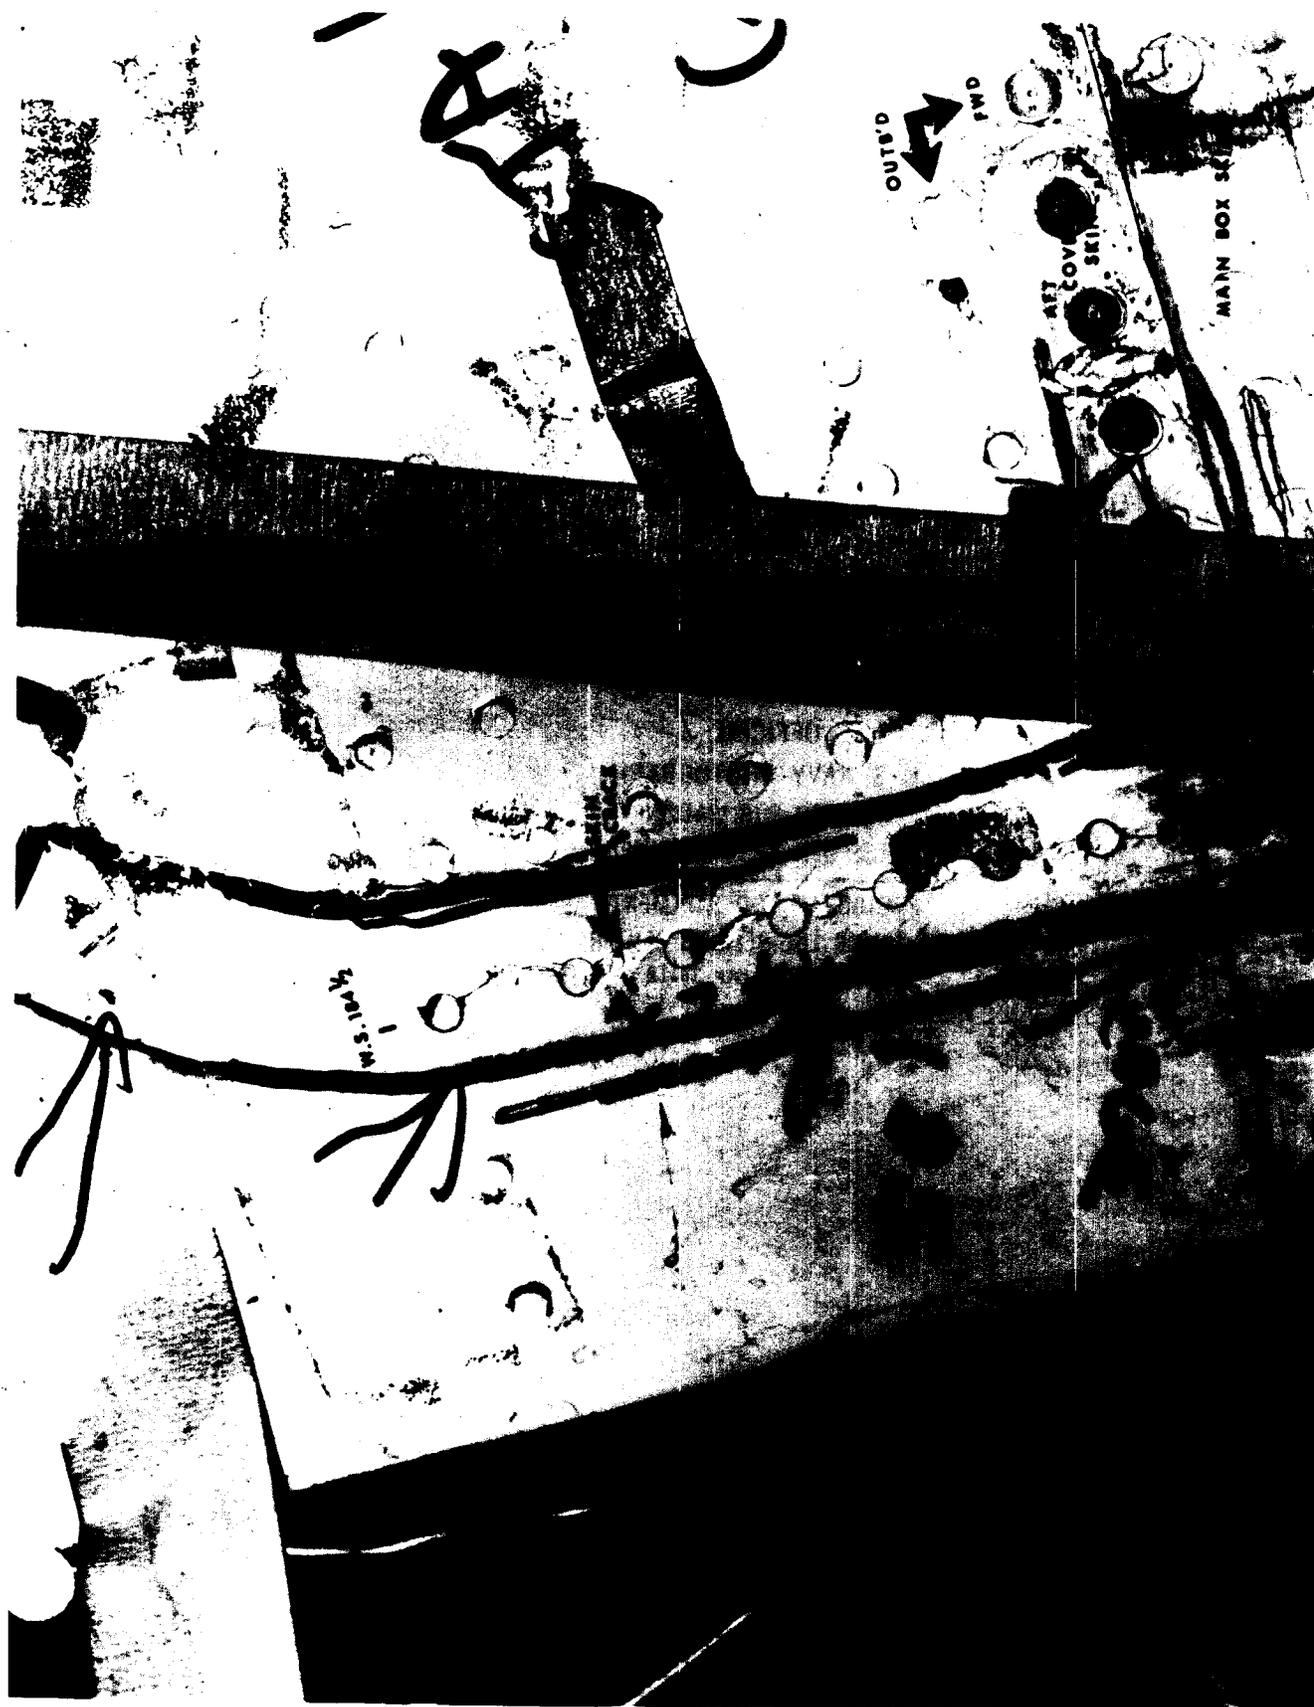
Block 615 (12,300 test hours): At the 105% l.l. a crack developed in the left-hand wing, aft-cover skin as shown in photo 21. This crack originated at the aft-cover main-beam skin fastening rivet at W. S. 184 1/2 and extended approximately 7 inches. This crack was stop-drilled and testing resumed. Prior to test resumption, a visual inspection of the interior of the wing at the jack pad holes was performed. This inspection which was hampered by the presence of sealant did not reveal any structural damage.

As discussed under Results, a crack was observed in the aft-cover skin at 12,300 test hours. It is apparent that this crack was an indication that complete failure was imminent. If the GAC strap is installed on a service aircraft and an aft-cover skin crack occurs, the aircraft should be grounded. It should be borne in mind, however, that this crack occurred only 200 test hours prior to final failure. Therefore, its use as a failure indicator is extremely limited.

PHOTO 21. CRACK IN LEFT-HAND WING AFT-COVER SKIN

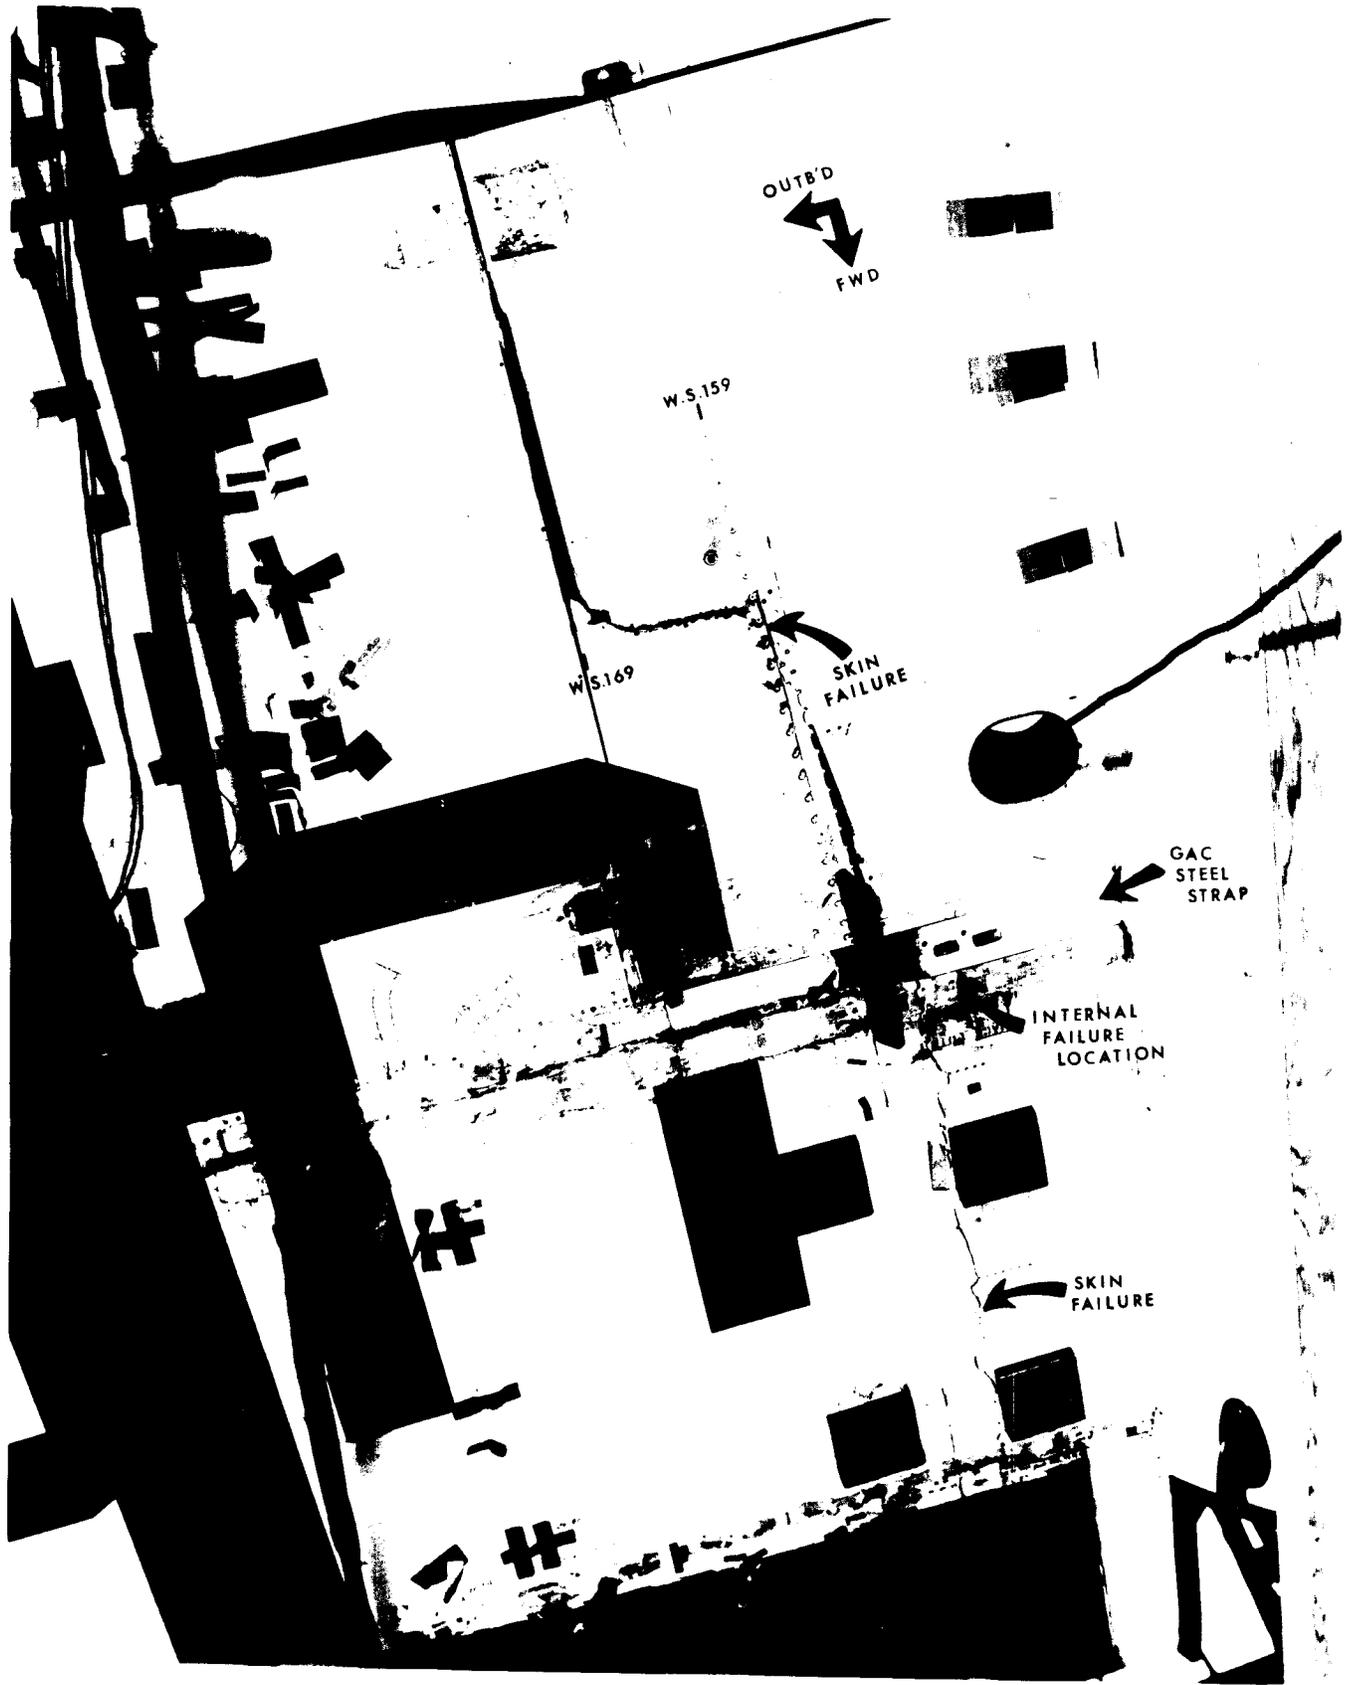
PHOTO NO: CAN-397090(L)-11-69

Block 625 (12,500 test hours): At the 105% l.l. a catastrophic failure of the left-hand semispan center section occurred. This failure, shown in photo 22, was almost identical to the right-hand semispan failure. The major difference was that the failure originated at the inboard jack pad hole rather than at the outboard hole as in the right-hand wing failure. Examination of the fracture surface indicates a large amount of exfoliation, as evident in photo 23, and a large number of beach marks. Counting in toward the failure initiation point, 43 striations (representing 215 blocks of load or 4,300 test hours) predominately emanating from the plugged rivet holes, are visible to the eye prior to beach mark wash out. This wash out area is about six times larger than that of the right-hand wing fracture surface. Fatigue markings are also evident in the lower internal steel strap, also shown in photo 23. Secondary failure of the GAC steel strap also occurred. The failure mode was shear tear out at the single fastener at W. S. 160 1/2.

PHOTO 22. LEFT-HAND WING FAILURE
