Determination of the Life Remaining in the Model HU-16E Airplane Wing

REPORT NO. NADC-ST-7007

DETERMINATION OF THE LIFE REMAINING IN THE
MODEL HU-16E AIRPLANE WING

FINAL REPORT

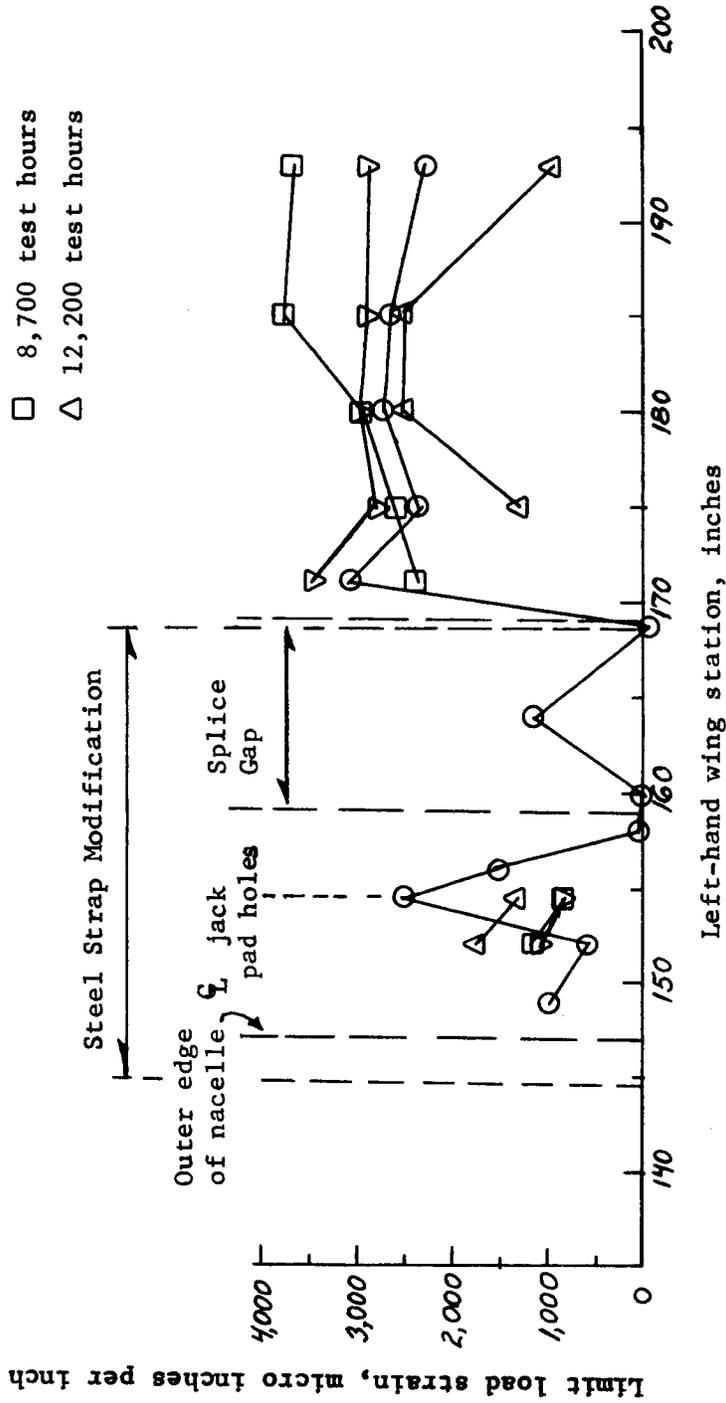
Figure 6

Strain gage readings were taken at various times during the test program. The results of these readings are listed in table 7 and plots of some of the readings are shown in figures 6 and 7. As is shown, there was a significant change in strain after the installation of the GAC steel strap. However, there were no changes in strain prior to failure which might have indicated impending failure. Wing deflection measurements were also made during the program. A listing of the results of these measurements can be found in table 8.

STRAIN DISTRIBUTION, MAIN BEAM LOWER SPAR CAP

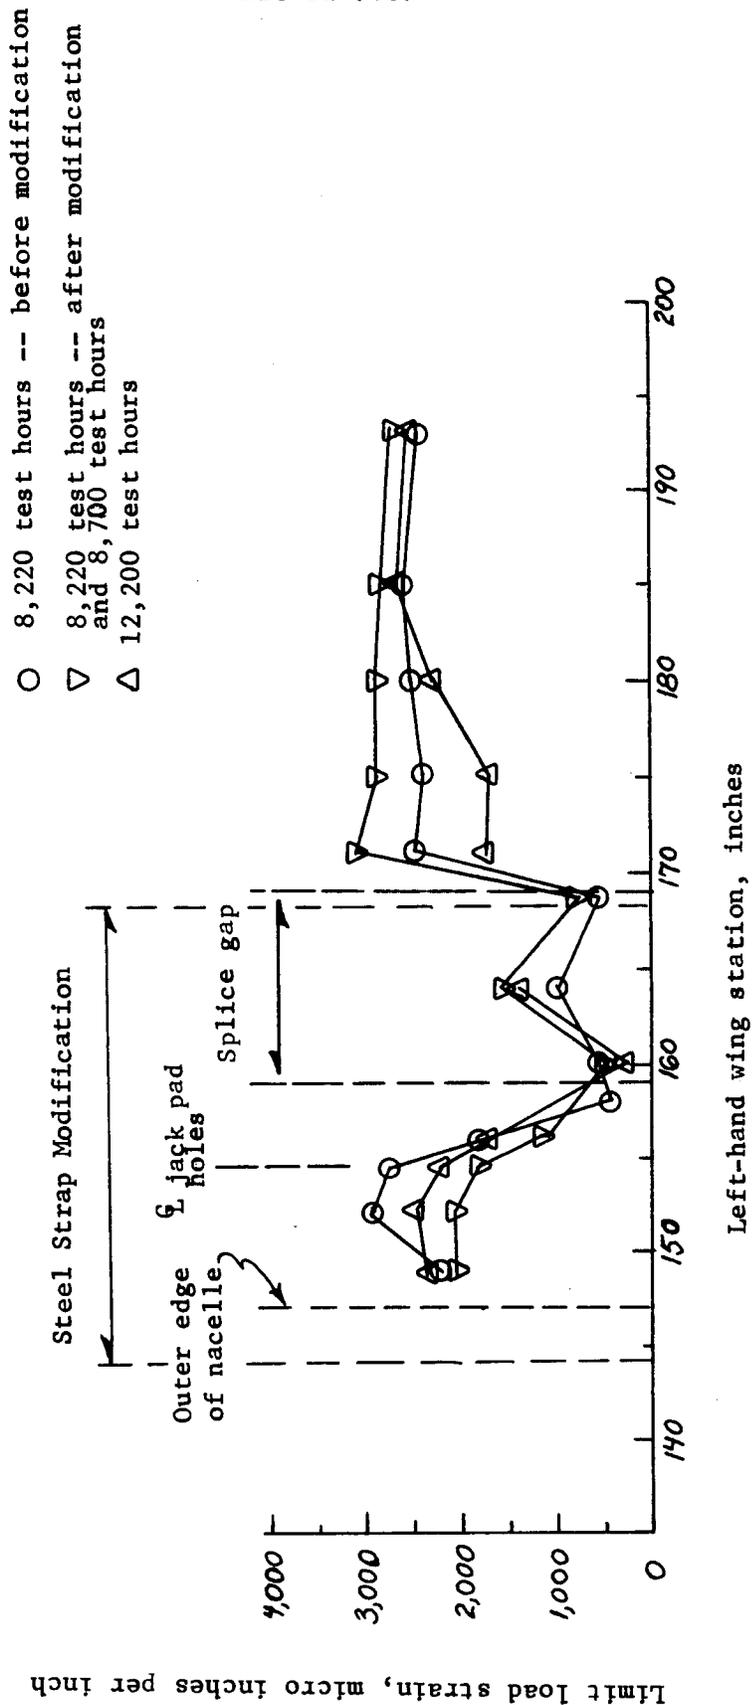
Figure 7

STRAIN DISTRIBUTION, FORWARD OF MAIN BEAM LOWER SPAR CAP
